The deadliest cargo

Nickel ore has recently been described by Intercargo as the deadliest cargo in the world. This label is understandable, given the statistics, but what is behind it?

John Poulson

Principal Surveyor, Atlantic Marine Associates

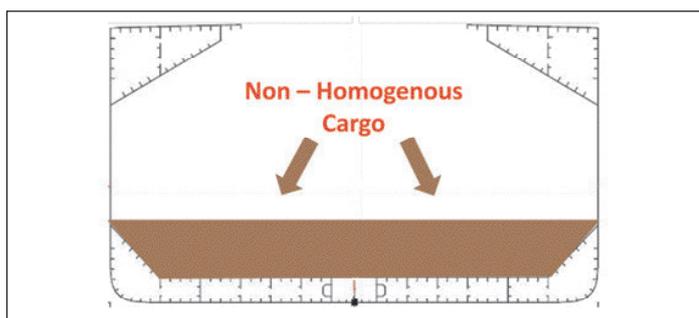
Fig 1: Moisture migration

One problem is that of moisture migration. Loading cargo from barges can take some time. Different particle sizes and different water content can produce a non-homogenous mixture (Fig 1). During the voyage, moisture can migrate causing a wet base to develop (Fig 2). Even then, capsizing still seems to need a catalyst. In the case of the *Harita Bauxite*, that catalyst was stopping at sea, but it could be a course alteration or heavy weather.
